NATIONAL SHORELINE STUDY. HAWAII REGIONAL
INVENTORY

Hawaii Regional Inventory

National Shoreline Study

HONOLULU, HAWAII
AUGUST, 1971

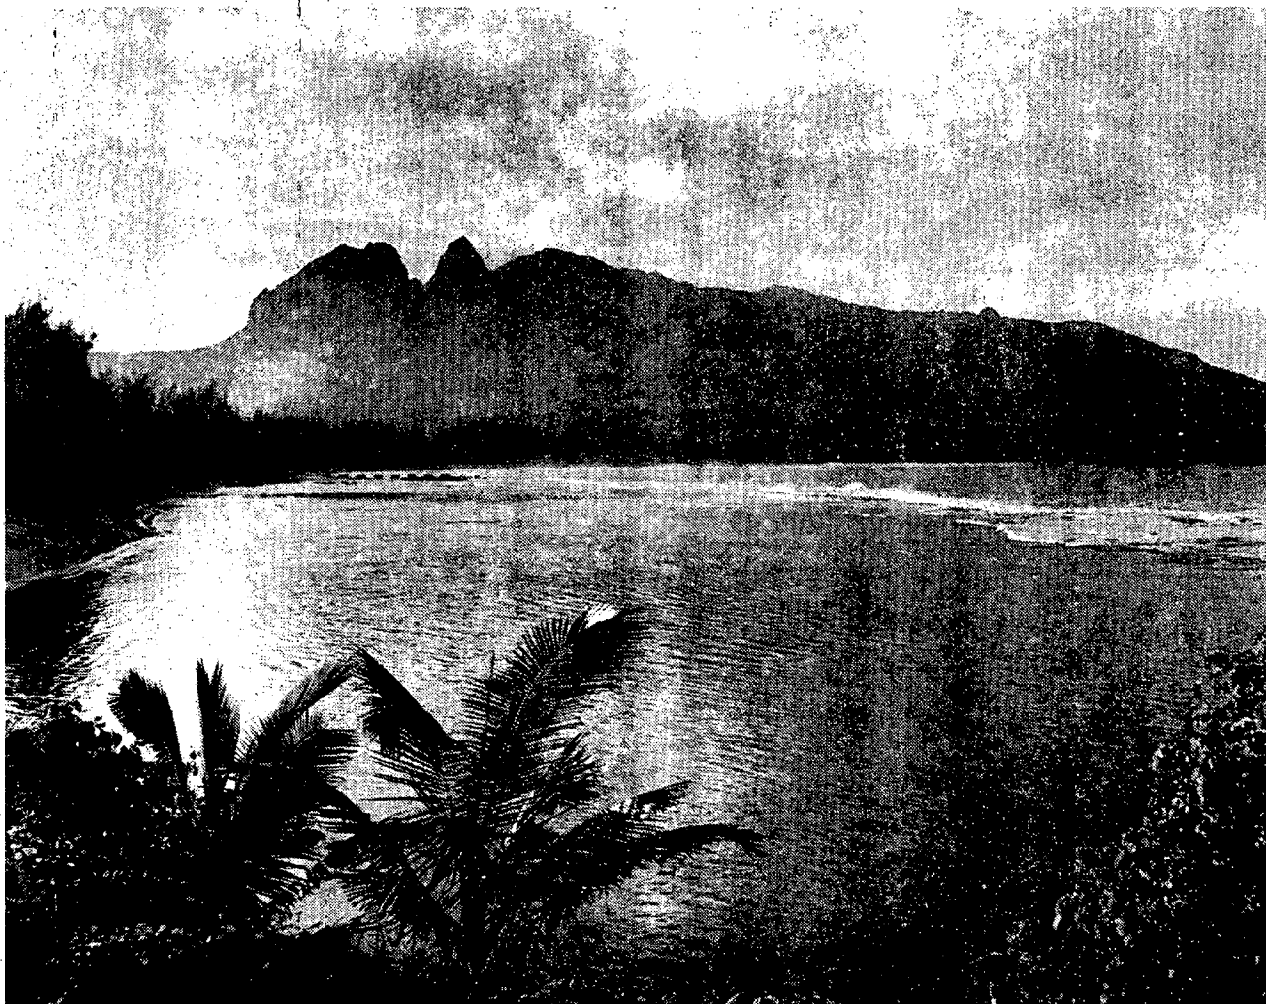
Fig. 5 Anahola Beach, Kauai (Camera Hawaii Photo)

width of 150 feet. This slightly arcuate beach is from 170 to 220 feet wide near the center and narrows to about 100 feet at both ends (figure 5). The beach has a low slope and at least one berm. Beach sand is predominantly calcareous and of medium-grain size. The offshore is essentially sand, and low sand dunes lie behind part of the beach. The beach is subject to seasonal accretion and erosion, and to changes resulting from lateral shifts in the mouth of the perennial Anahola Stream. During the 16-month study of Hawaiian beaches conducted by the University of Hawaii, the position of the stream mouth changed by about 500 feet.

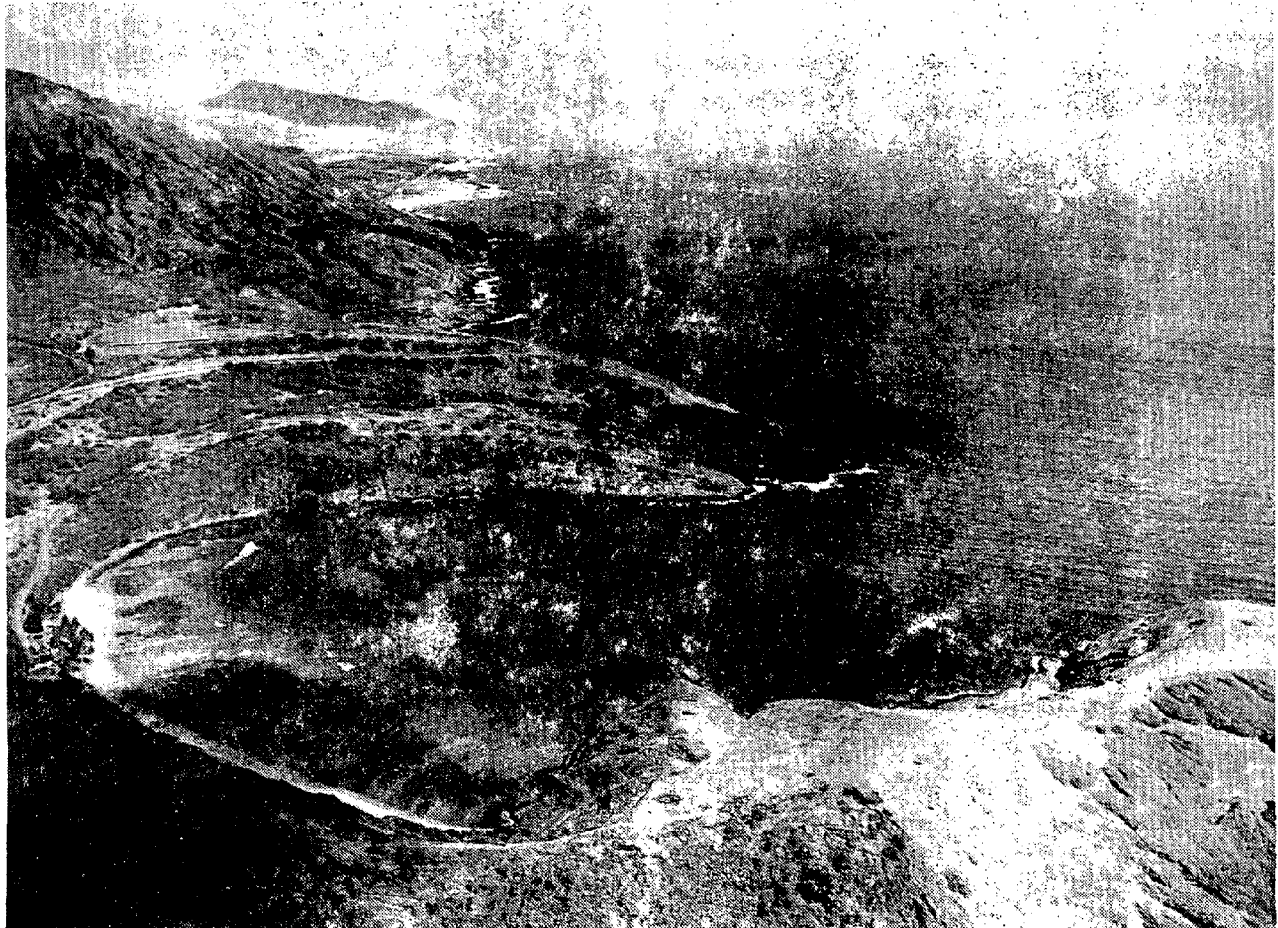
Fig. 6 Rocky coastline between Hanauma Bay (lower left) and Wawamalu Beach Park (upper left), Oahu

Except for Hanauma Beach Park, the coastline from Halona Point to Maunaloa Bay is an extremely rocky, terraced sea cliff affording only marginal accessibility (figure 6). The 1,800-foot-long, 30-to 100-foot-wide sandy beach at Hanauma Bay had been eroding to the extent that coconut trees about 20 feet inland from the shoreline were being undermined (figure 7). In April 1970, the City and County of Honolulu, Department of Parks and Recreation, initiated remedial action for the beach park. The beach erosion control project consisted of construction of a wave barrier, restoration of the beach (figure 8), and excavation of a new swimming area.

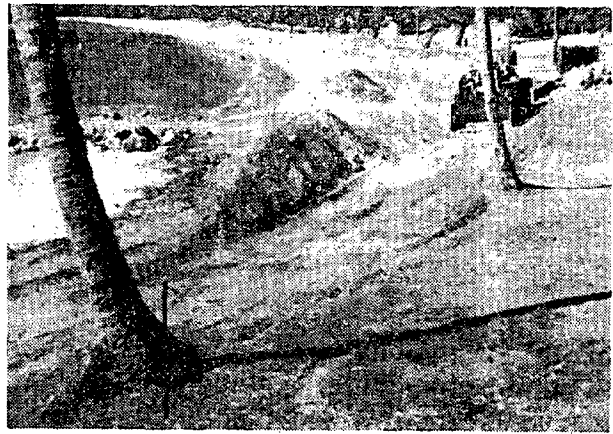
Fig. 8 Restoration of the beach at Hanauma Bay Beach Park, Oahu.

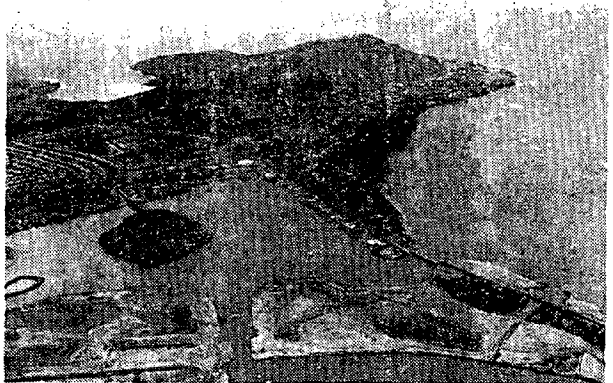
Fig. 9 Maunalua Bay area, Oahu

The shoreline of Maunaloa Bay has been considerably altered by artificial structures which include a boat launching ramp, seawalls along the residential area at the east end of the bay and coral fill which was placed along the center section during initial development of a marina-oriented residential area in

the valley behind the bay (figure 9). The coral fill area is part of the Maunalua Beach Park, and is fronted by a 1,000-foot-long 10-foot-wide sand beach which is gradually eroding. The offshore area of the bay is characterized by one of Hawaii's shallowest reefs. Relatively few organisms appear to be living on this reef-flat where local patches of sand have been observed.

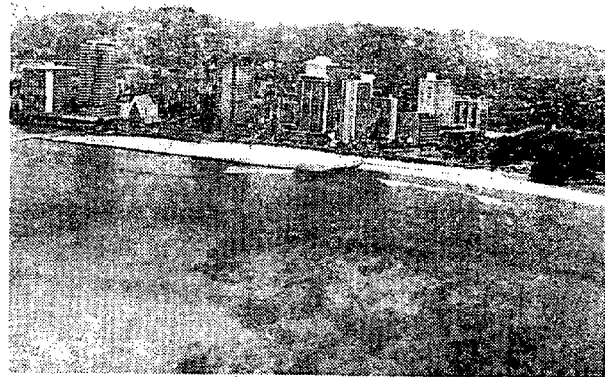
Fig. 14 Eroded conditions of the Kuhio Beach sector of Waikiki Beach

actions have been independently pursued by various interests, including property owners, the City and County of Honolulu, the State of Hawaii, and the Federal Government. Remedial measures have included construction of a variety of structures such as seawalls, cribwalls, and rubblemound and sandbag groins. The effectiveness of these structures vary; however, the net effect has been minor, and erosion is still a problem at this beach. The severity of the problem is exemplified by a brief history of Kuhio Beach, a 1,500-foot-long reach in the center of Waikiki Beach. Action taken in May 1939 to curb erosion at this beach resulted in placement of a 150-foot-wide beach. However, within eight years, a section of the beach was completely denuded. Action taken by the Territory of Hawaii in 1951 resulted in, among other things, placement of a 150-foot-wide beach. However, erosion has continued to occur, so that the existing beach varies in width from 0 to 230 feet (figure 14). The remaining reaches of this famous

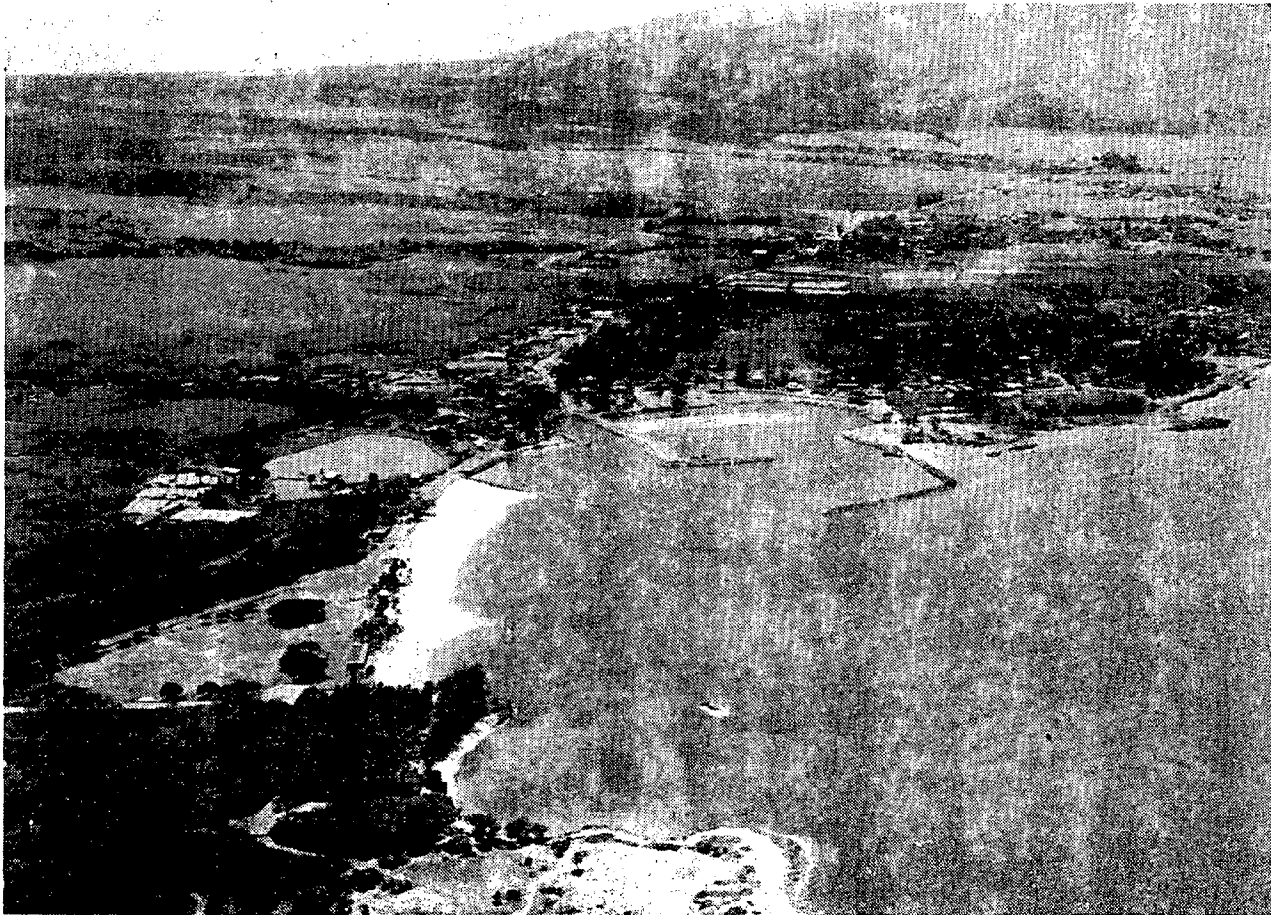
Fig. 18 Aerial view of Haleiwa Harbor and Haleiwa Beach Park, Oahu.

Haleiwa Beach Park, which lies immediately east of the boat harbor, has experienced critical erosion. In December 1949, the entire shoreline from the north end of the park to the mouth of the Anahulu River was fronted by an excellent sand beach which ranged in width from approximately 90 to 130 feet above mean lower low water. However, during the early 1950's gradual erosion was observed. This erosion continued, and by December 1965 the beach fronting a section of the park had eroded to within two feet of a seawall which collapsed two months later. On March 9, 1957, a large volume of sand was lost due to a tsunami which originated in the Aleutian Islands. The severity of continued erosion of this beach justified Federal participation in a beach erosion control project which was completed in 1965, and resulted in, among other things, a 1,600-foot-long beach with a width varying from 140 to 265 feet above the mean lower low water line (figure 18). However, this beach, as well as the adjacent small boat harbor, was again severely damaged during the storm of December 1969. Sections of protective structures such as breakwaters and groins were damaged and approximately 7,000 cubic yards of sand were lost. As a result, the State of Hawaii requested Federal participation in emergency repair work for the beach park and small boat harbor. In November 1970, the Corps of Engineers completed repair of the damaged groins and offshore breakwater, and placement of about 7,000 cubic yards of sand over the eroded sections of the beach.

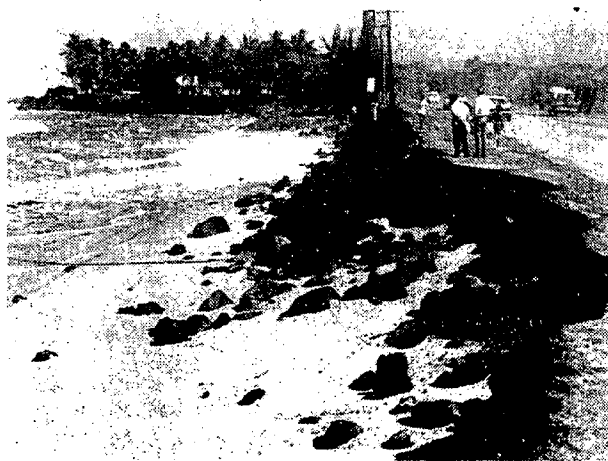
Fig. 19 Damage to a section of the coastal highway along Kaiwailoa Beach, Oahu

Kawailoa Beach, a two-mile reach extending east from Haleiwa Beach Park, consists of alternating stretches of sandy beach and outcrops of lava and beachrock. The beach is predominantly medium grains of highly calcareous sand. It changes seasonally and experiences up to 40 feet of erosion during the winter. During the last few years, erosion along a 2,000-foot-long reach has encroached on residential property to the extent that remedial measures are required. The high waves during December 1-4, 1969, resulted in considerable loss of sand, structural damages, and loss of property (figure 19).

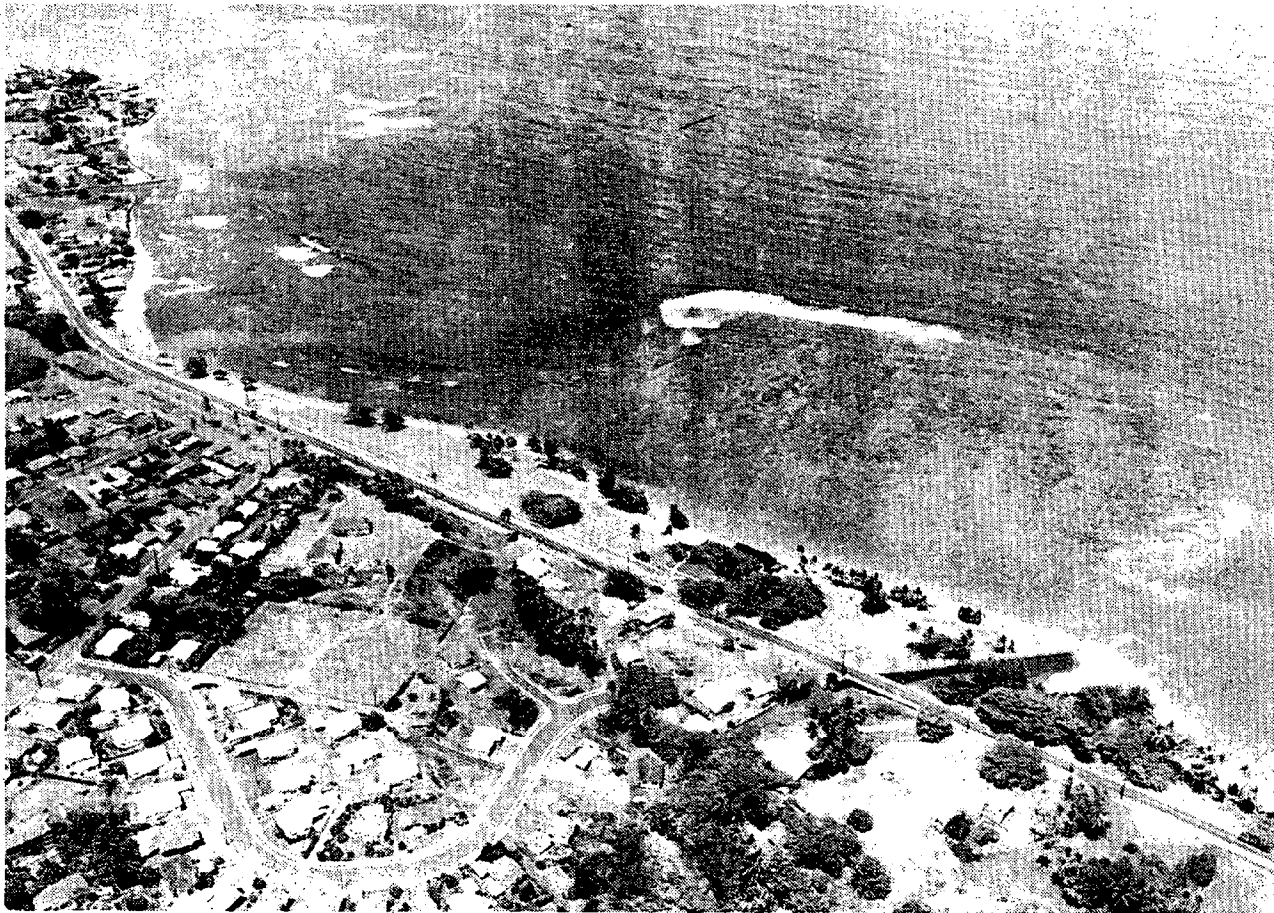
Fig. 20 Aerial view of Hauula Beach, Oahu

The fairly straight but narrow beach fronting the public park at Hauula is 2,000 feet long and 40 feet wide (figure 20). There is no berm along this beach which has a moderately steep foreshore. The sand is composed of fairly well sorted, medium-sized grains, about four-fifths of which are of calcareous material. Erosion since 1935 has claimed an average of 14 feet of beach along a 1,400-foot reach. In November 1969, the top of the beach slope along the northern end of the park was within 5 feet of an adjoining highway right-of-way. Toward the southern end of the park, the top of the beach slope was within 3 feet of the park pavilion which houses a concession stand and bathhouse. The top of the slope along the central section extended along a line of 14 ironwood trees which have been partially undermined by erosion.

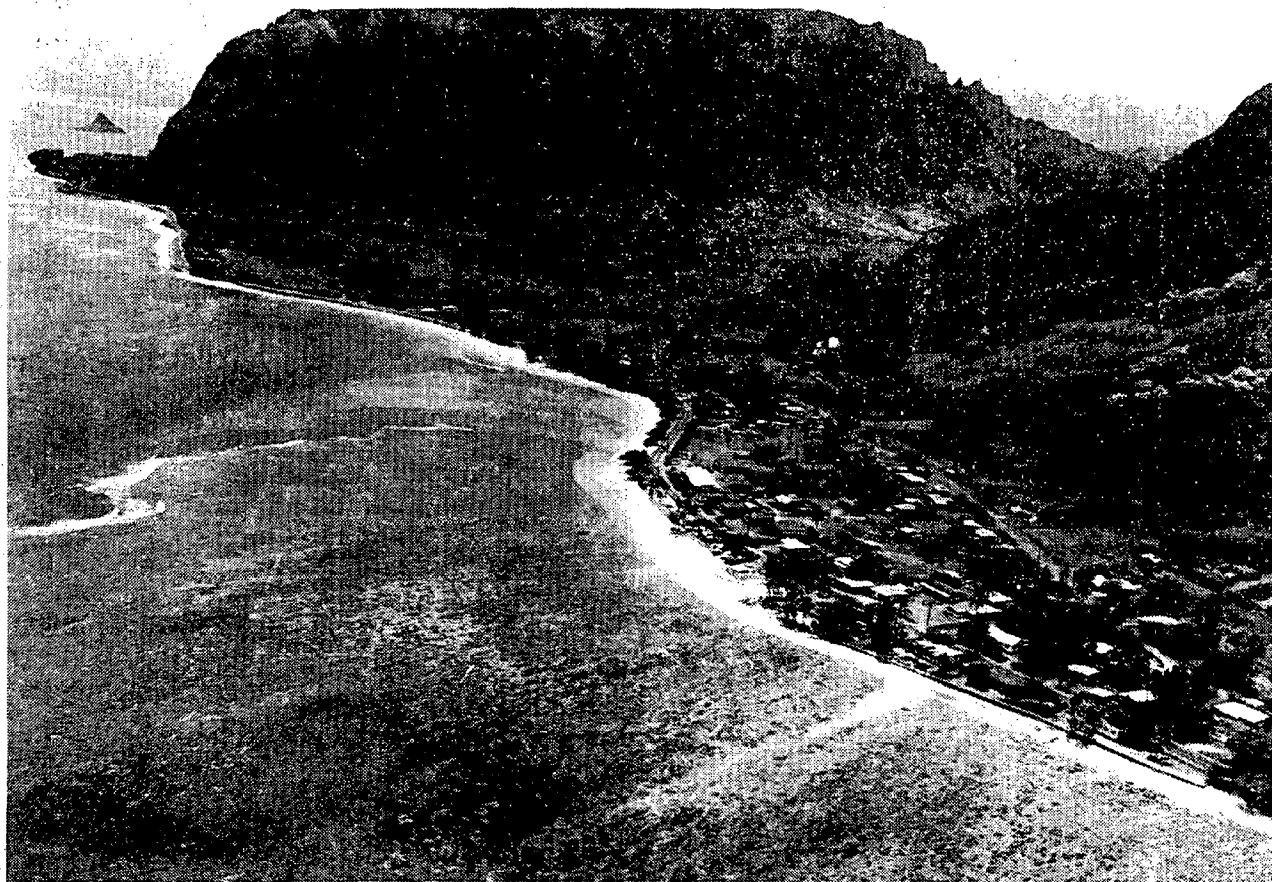
Fig. 21 Aerial view of Kaaawa Beach, Oahu

The 1,700-foot-long, 40-foot-wide beach at Kaaawa Beach Park has been subject to erosion over the years (figure 21). Since early 1962, from 40 to 60 feet of land has been lost due to erosion along the entire length of the beach. High waves during December 1968 and January 1969 were particularly damaging, and caused undermining of numerous coconut trees as well as the park's comfort station. In December 1968, the City and County of Honolulu Department of Parks and Recreation dumped rocks around many coconut trees, the comfort station, and along a portion of the beach berm as an emergency measure to retard erosion. Construction of a new pavilion-bathhouse was postponed because of the severity of the erosion problem.

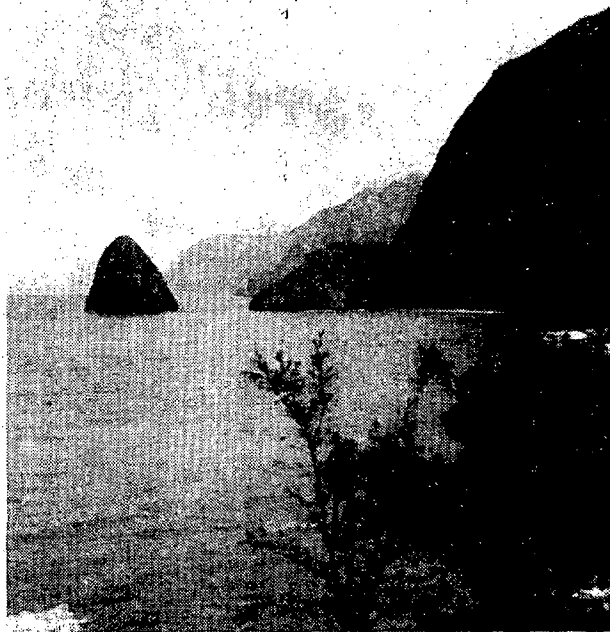
Fig. 25 Sea stack and steep seacliffs along the northeast coast of Molokai

Northeast Shore (plate 23). The shoreline from Kalaupapa Peninsula to Cape Halawa is one of the most spectacular reaches of Hawaii's shoreline. This reach consists of sea cliffs which are more than 3,000 feet high in the central section and about 100 feet high at both ends (figures 25 and 26). It is interrupted by large valleys at Waileia, Waikolu, Pelekunu, Wailau, Papalaua, and Halawa, all of which have alluviated bottoms and some of which have beaches at the valley mouths.

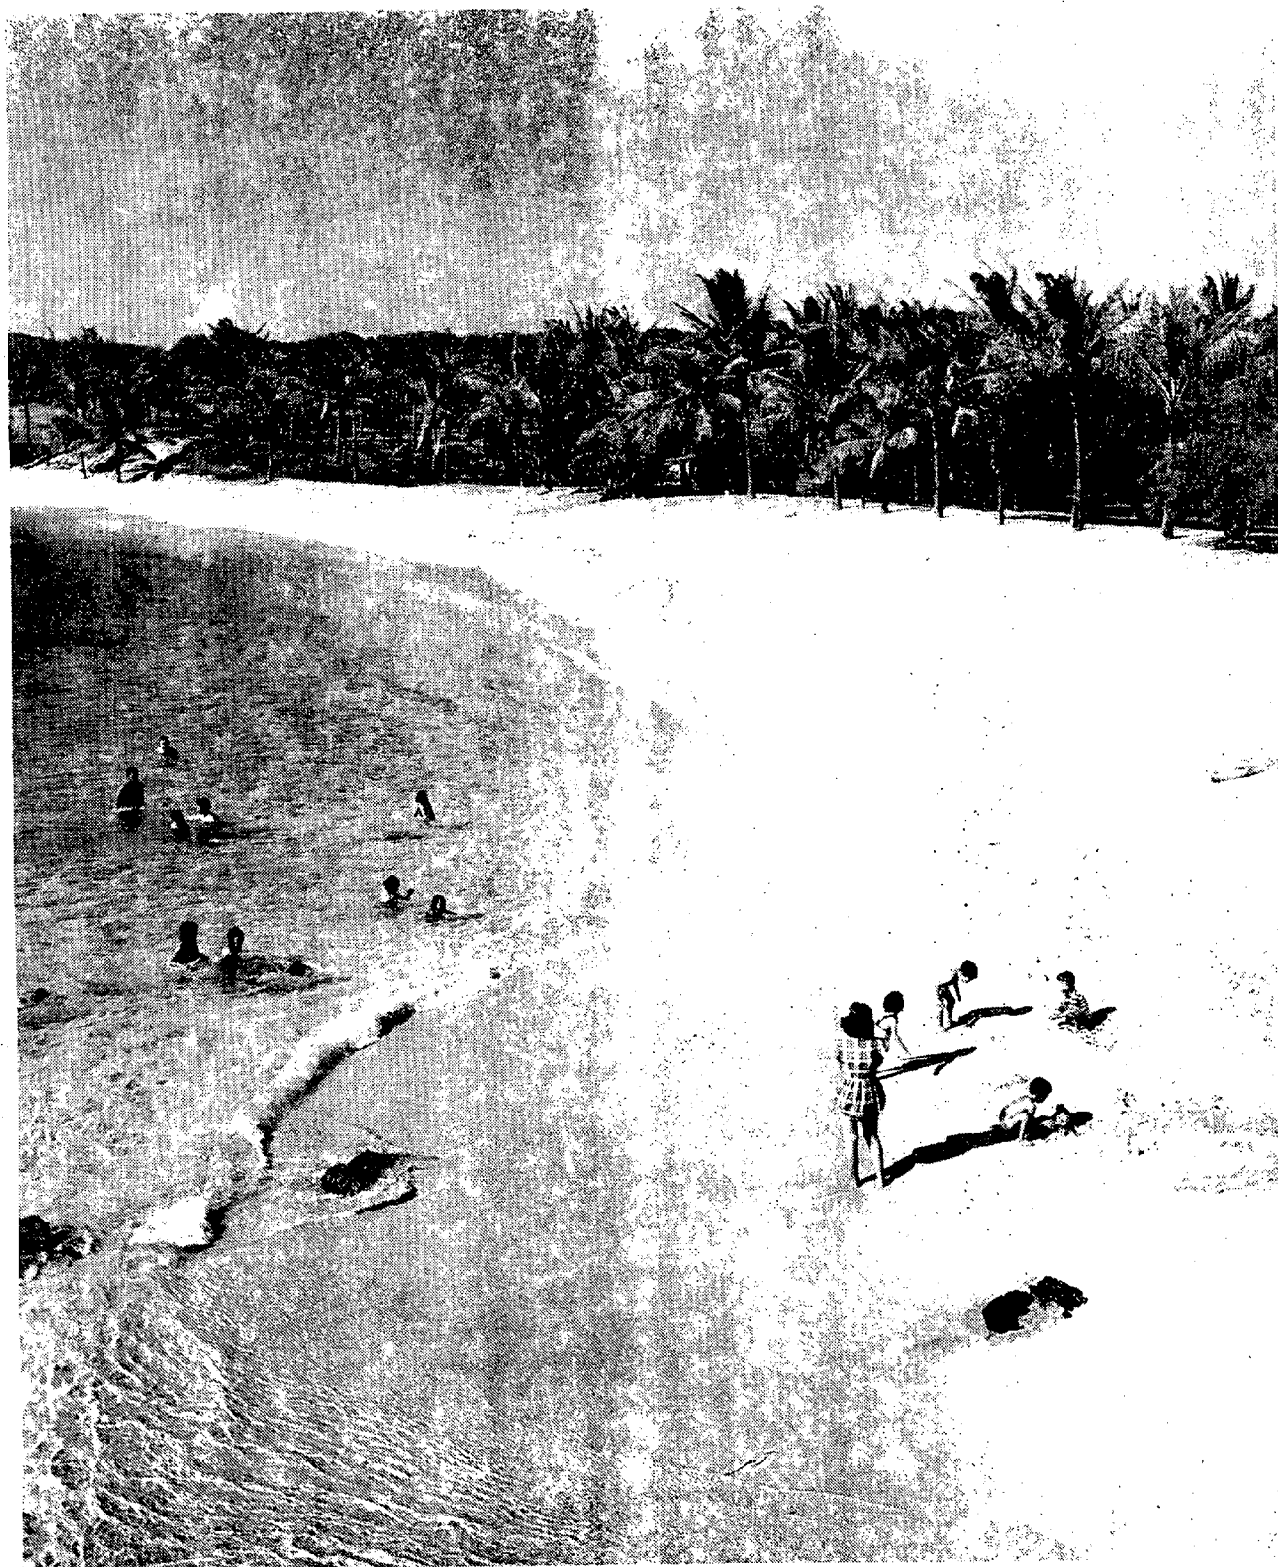
Fig. 30 *Flemings Beach, Maui (Camera Hawaii Photo)*

The 700-foot-long, 90-foot-wide Flemings Beach is another of the pocket beaches along the western end of the north shore (figure 30). The beach terminates

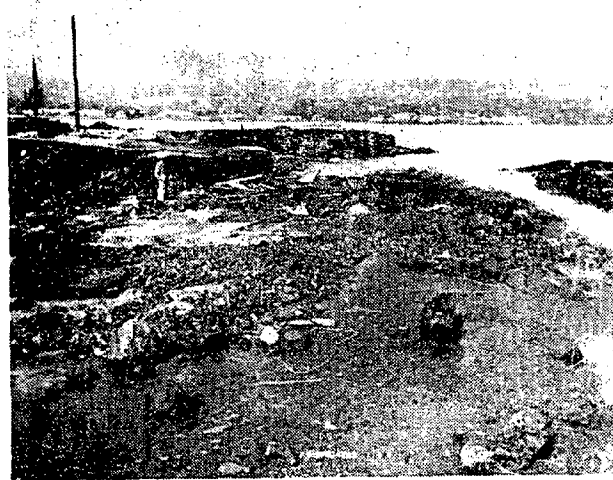
Fig. 32 Destruction along a section of Hilo Bay resulting from the tsunami of April 1, 1946

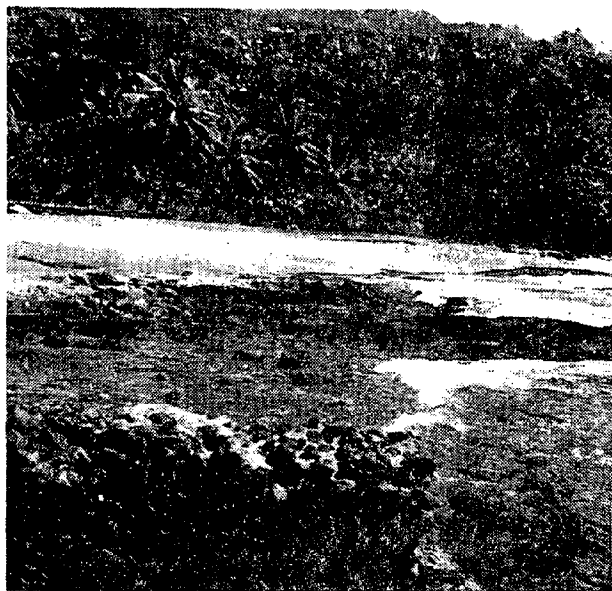
Fig. 36 Hookena Beach, Hawaii

The 600-foot-long, 100-foot-wide arcuate pocket beach at Hookena is one of the few sandy beaches within this reach. The beach is bound at each end by basaltic rock and along the backshore by a 100-foot-high fault escarpment of lava basalt (figure 36). Nearly equal proportions of volcanic and calcareous grains form the medium-sized, moderately sorted sand which extends inland beneath a coconut grove to the talus at the base of the fault escarpment. The sand extends about 100 feet from shore.

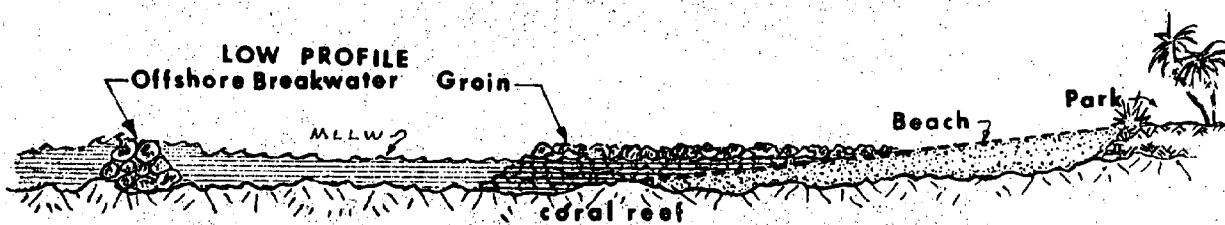
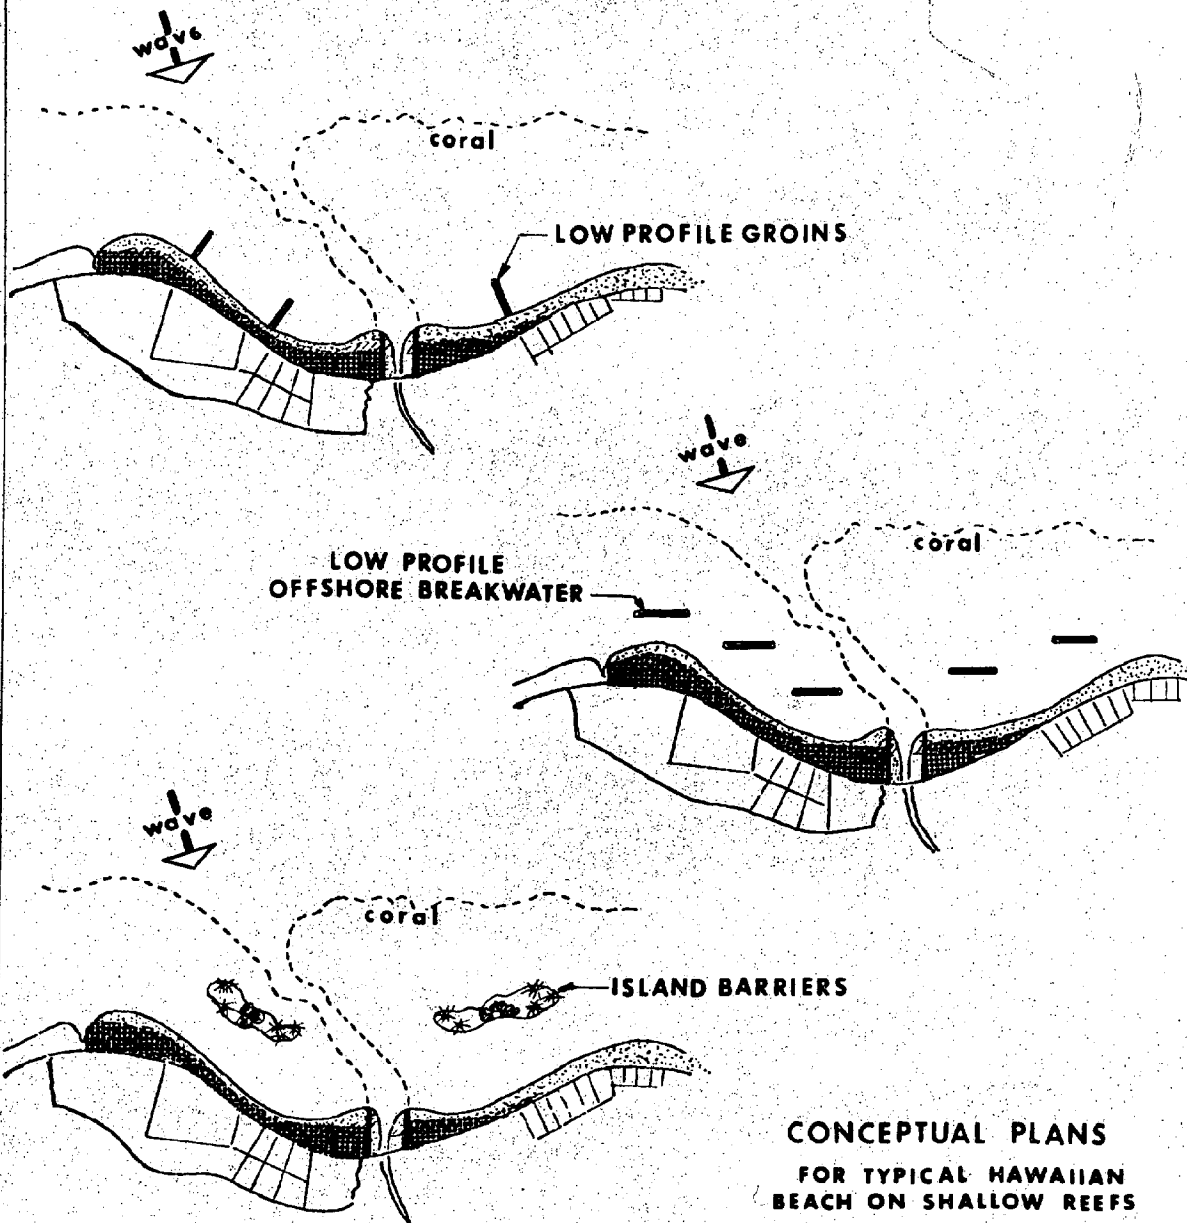
CONCEPTUAL PLANS
FOR TYPICAL HAWAIIAN
BEACH ON SHALLOW REEFS

TYPICAL SECTIONAL VIEW
